**Information Bulletin
of the Steel Industry Safety and
Health Commission**

Accidents

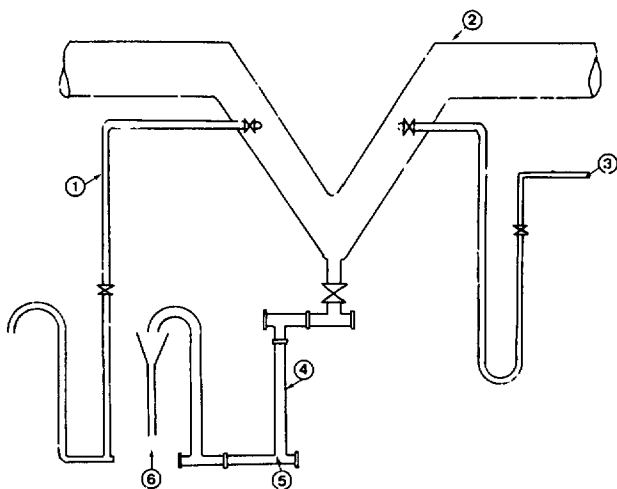
The leakage occurred from an 8" diameter drain valve leading to a 'U' seal drain. The valve was attached to a water seal on a 96" diameter Blast Furnace gas main (see sketch). The contractors-pipe fitters, electricians, a welder, a storeman and a foreman, were working in the vicinity of an open Circuit Pump House and Contractors' Compound approximately 55 yards from the water seal. During the morning, a fitter's mate who had been engaged on aligning pumps, collapsed in the Contractors' Compound. Approximately 15 minutes later an electrician collapsed and other personnel were taken ill at the open circuit pump house. The work's surgery was informed of both incidents and 15 persons were treated for carbon monoxide poisoning.

Examination of the installation showed that the gas leakage had resulted from the corrosion and subsequent holing of the drain seal pipework and consequential loss of the water seal. The corrosion had not been detected because of the lagging enclosing the pipework. The lagging was made of polystyrene and it is possible that this would tend to prevent any water escaping and increase the risk of corrosion of the pipework. Weather conditions at the time, mist with very little breeze, were not conducive to gas dispersal.

1. Water seal overflow
2. 96" in. dia. blast furnace gas main
3. Water inlet
4. 8" dia. drain seal lagged with polystyrene
5. Holes in pipework
6. Drain to soakaway

1. The lagging on the drain seals and inlet and overflow water pipework on all 26 main water seals on the plant will be removed. The exposed pipework will be examined and repaired or replaced as necessary.
2. Specialist advice will be sought on corrosion protection for this pipework and the desirability of future re-lagging. If re-lagging is recommended, a suitable frequency for pipework examination will be determined from this source.
3. Contractors' personnel to be instructed as to the possible effects of carbon monoxide poisoning.
4. The medical department must be advised of the site locations of contractors.

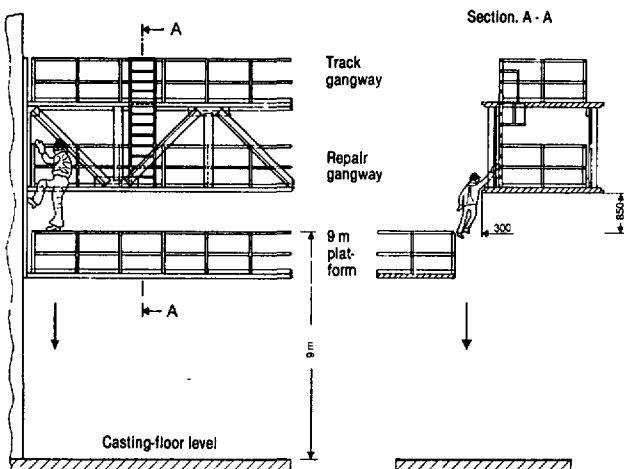
A crane driver in a steelworks had transported a casting ladle to the repair shop for stripping of the refractory lining. The stripping operation took rather a long time, so he left his crane and, in order not to have to take the 60 metres long regulation track gangway to descend, he climbed down a ladder from it onto the repair gangway below. He climbed over the railing of this gangway to get down onto the railing of the 9 m platform, and in doing so lost his hold and fell 9 metres onto the shop floor, where he died of his injuries.

The cause of this tragic accident was that the crane driver took a short cut in the form of the 'climbing operation' described above, instead of taking the completely safe descending stairway at the end of the regulation track gangway.

All possible short-cuts were fenced off.

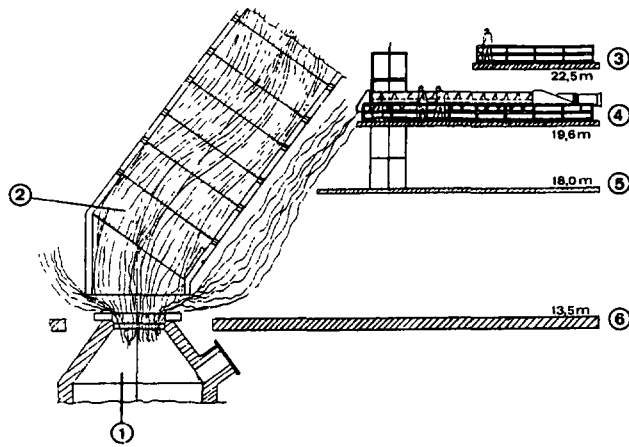
A shift foreman and three fitters were on the 19.6 m platform above the converter of a BOP shop, engaged on repairs to a continuous conveyor. The men began their work whilst the converter was being charged with 15 t. scrap and 0.8 t. molybdenum oxide. The charging box was then moved to the side and pouring of the pig iron began. As there was trouble with the tilting of the pig iron ladle (skull formation), this process had to be suspended after 12.1 t. of pig had been charged. To rectify the fault, the ladle was withdrawn and the converter tilted towards its original position. Immediately after the converter had reached the vertical, an unusually large quantity of carbon monoxide emerged from the mouth and caught fire. The flames were not completely trapped by the hood but escaped between it and the converter. They reached the working platform at 19.6 m on which three of the four men were busy with repairs. These men received severe burns and despite immediate first aid measures, died.

1. Converter
2. Hood
3. Platform
4. Repair platform
5. Platform
6. Platform

The investigation of the accident revealed that the carbon in the pig iron reacted spontaneously with the oxygen of the molybdenum oxide when the converter was tilted back to the vertical. The quantity of carbon monoxide formed by this very rapid reaction was so great that the hood was not able to trap all of it.

The danger zones were determined for every part of the converter by means of a hazards survey analysis. In addition, it became a formal requirement that the system of 'free-for-operation certificates', introduced some time previously, be respected to the letter. A further finding from the investigation was that molybdenum oxide should be distributed over the scrap charging box so that it is also well distributed in the converter.

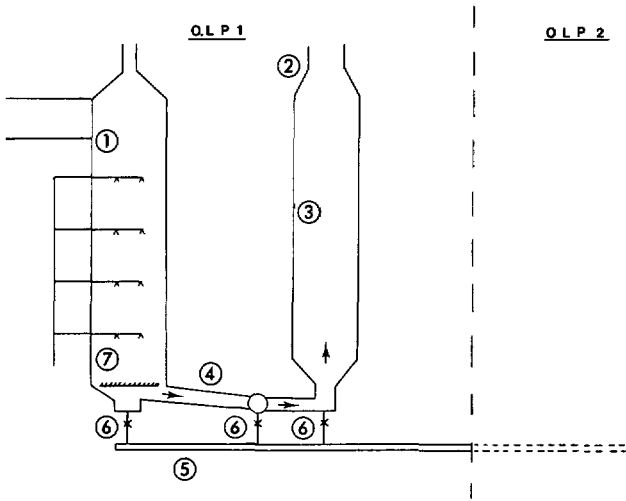
On the day of the accident, the safety regulations applicable to the task (shut down) were not observed for the third operation mentioned above, for the isolation valves to the sludge sewer had not been closed.

- 1. Washer (secondary cleaning)
- 2. Flare
- 3. Stack
- 4. Fan
- 5. Sludge sewer shared by both installations
- 6. Valve
- 7. Grate

- (i) Stressing to supervisory staff of the importance of the safety regulations applicable to this task.

- (ii) Reminder to the workers concerned of these regulations.
- (iii) Check *in situ* on the sound application of the shut-down procedure.
