**Information Bulletin  
of the Steel Industry Safety and  
Health Commission**

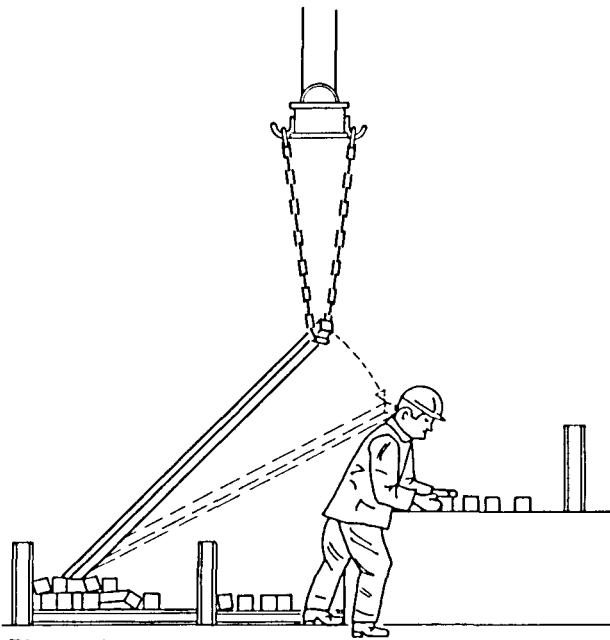
Figure 1.

## **Killed by falling billet 3/80**

Two billet trimmers were checking and trimming 60 mm square section billets, each approximately 8 metres long. The layout of the trimming section is such that the trimmed, usable billets can be tipped directly from the trimming station into the adjacent collecting pocket—whereas discarded scrap billets have to be removed to the scrap pocket by crane. During this process, the two trimmers carry out the slinging work themselves.

When the two trimmers had deposited a scrap billet in the scrap pocket they pulled the chains hanging from the cross beam over the front of the billet, as usual and threw them on to the billets lying in the scrap pocket. They then gave the crane driver the signal to raise the cross beam and returned to the trimming station to resume work there. When the cross beam was lifted, a chain sling caught the end of a deposited billet and raised it, without this being noticed. When the crane driver had raised the cross beam to the normal height, he drove the trolley to the normal waiting position above the billet trimming station. The billet which had been raised accidentally then slipped out of the chain and fell against the neck of one of the trimmers. The blow was so violent that the man died instantly (Fig. 1).

The accident could have been avoided if the crane driver and billet trimmers had kept their attention on the cross beam and its chain sling until the chains hung freely above the scrap pocket.

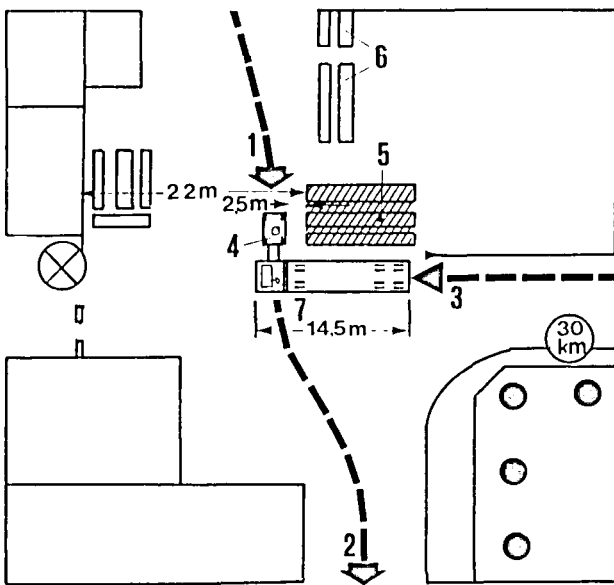
Figure 2. Diagram of the accident situation

### **Fatally injured in a collision on a factory road 1/81**

A foreman in a sheet metal processing plant was transporting a pile of sheet metal from the materials store to a production shop with a fork lift truck. On the direct route to the store a factory

road had to be crossed (Fig. 2). Since finished products packed in cases had been deposited between the production shop and the road, the foreman could not see into the road. A lorry driver who was driving along the road at the same time could not see if any traffic was coming from the right. When the two drivers arrived at the junction, they recognized the danger and braked sharply. However, they were unable to stop their vehicles quickly enough and the foreman drove into the lorry at the level of the driver's cab with the fork lift truck. He was thrown off the truck and run over by the lorry's double rear wheel. He died of his severe injuries at the scene of the accident.

This accident illustrates the need to ensure that visibility at road/road or road/rail junctions on factory premises is not restricted by deposited cases or stored material. Such areas must be kept clear; if necessary, by the installation of structures to prevent storage. If, for other reasons, it is not possible to keep the view unrestricted, e.g. in narrow thoroughfares between two factory shops, mirrors must be set up to improve visibility or traffic signs installed, e.g. stop signs or warning lights, to draw attention to the danger. Vehicle drivers must drive no faster than walking pace in these areas and must stop their vehicles, if necessary, in order to exclude any danger in driving over the junction.
