ORIGIN, MECHANISMS AND EFFECTS OF SALTS ON DEGRADATION OF MONUMENTS IN MARINE AND CONTINENTAL ENVIRONMENTS

March 25-27, 1996
Bari (Italy)

Protection and Conservation
of the European Cultural Heritage
Research Report n° 4

The E.C. Project
"Marine spray and polluted atmosphere
as factors of damage to monuments in the
Mediterranean coastal environment":
objectives and results

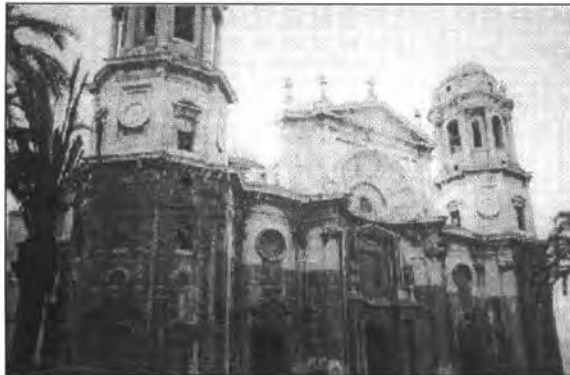
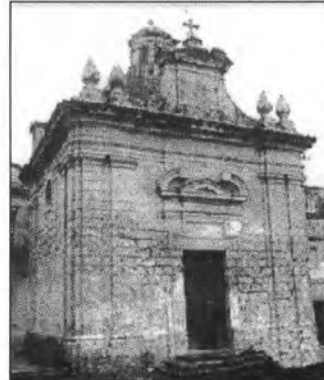
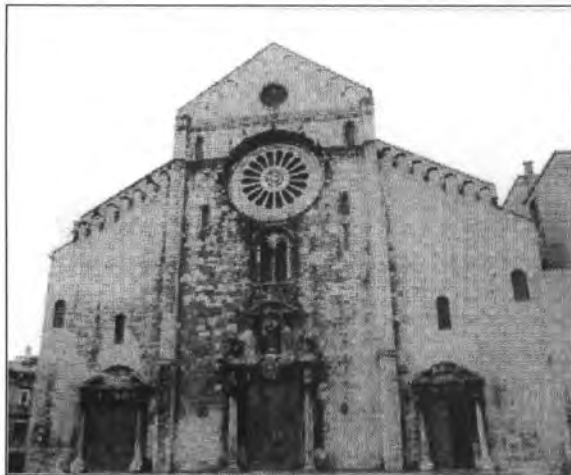
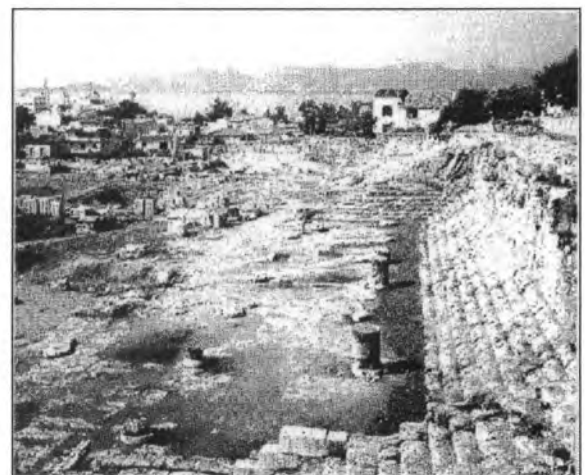
Fig. 1

LOCATION OF THE PILOT MONUMENTS ALONG THE E-W AXIS OF THE MEDITERRANEAN BASIN

Cathedral of Cadiz (XVIII Cent.)

Church of Sta. Marija Tà Cwerra in Malta (XVIII Cent.)

Cathedral of Bari (XII Cent.)

Sanctuary of Demeter in Eleusis (VI Cent. B.C. - Roman period)

Four pilot monuments were selected along the East-West axis of the Mediterranean (Fig.1) on which monitoring activities were programmed and advanced analytical procedures and non destructive techniques were applied. While these monuments had in common the lithotypes with which they were built (marbles, limestones and calcarenites), so that correlations can be made between them, they are also exposed to different conditions from a morpho-climatic point of view and in terms of air pollution and exposure to the sea-spray of the areas in which they are located. Also, the lithotypes, in common with many other monuments, because these stone materials have been widely used in the whole Basin, have been exposed to weathering for a time which varies between 200 and 2000 years up to the present day.

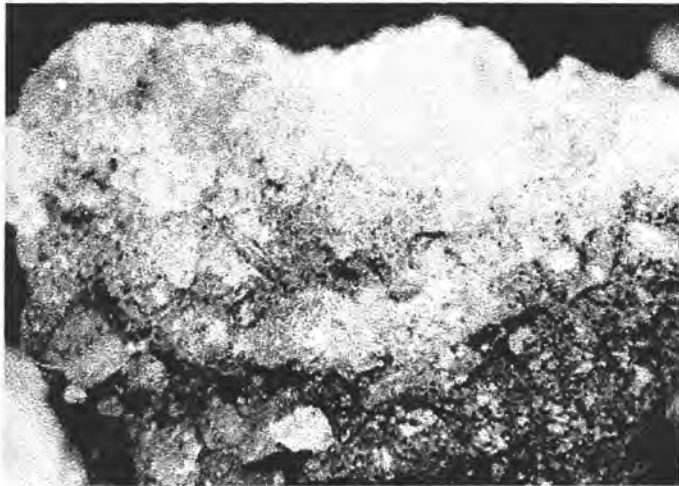
BIODETERIORATION

ments (melanins and carotenoids) that protect them from the effects of these two factors (Fig. 6). Also the bacteria, such as *Geodermatophilus*, present in black crusts of the marbles are melanin-producers and live in "extreme" habitats such as desert areas where they are closely linked to the so-called "desert varnish" on rock surfaces. Apart from lichens, the micro-organisms colonizing the rock surface are distributed as clusters of cells diffused along the surface and in microcracks, occupying cavities due to a biopitting phenomenon; colonization in inter and intra-crystalline cracks causes decohesion among crystals and their detachment. The bacteria colonies present on limestone and marble are mainly represented by *Bacillus*, *Streptomyces*, *Micrococcus*; among fungi *Cladosporium*, *Ulocladium*, *Cephalosporium* and *Phoma* are also found.

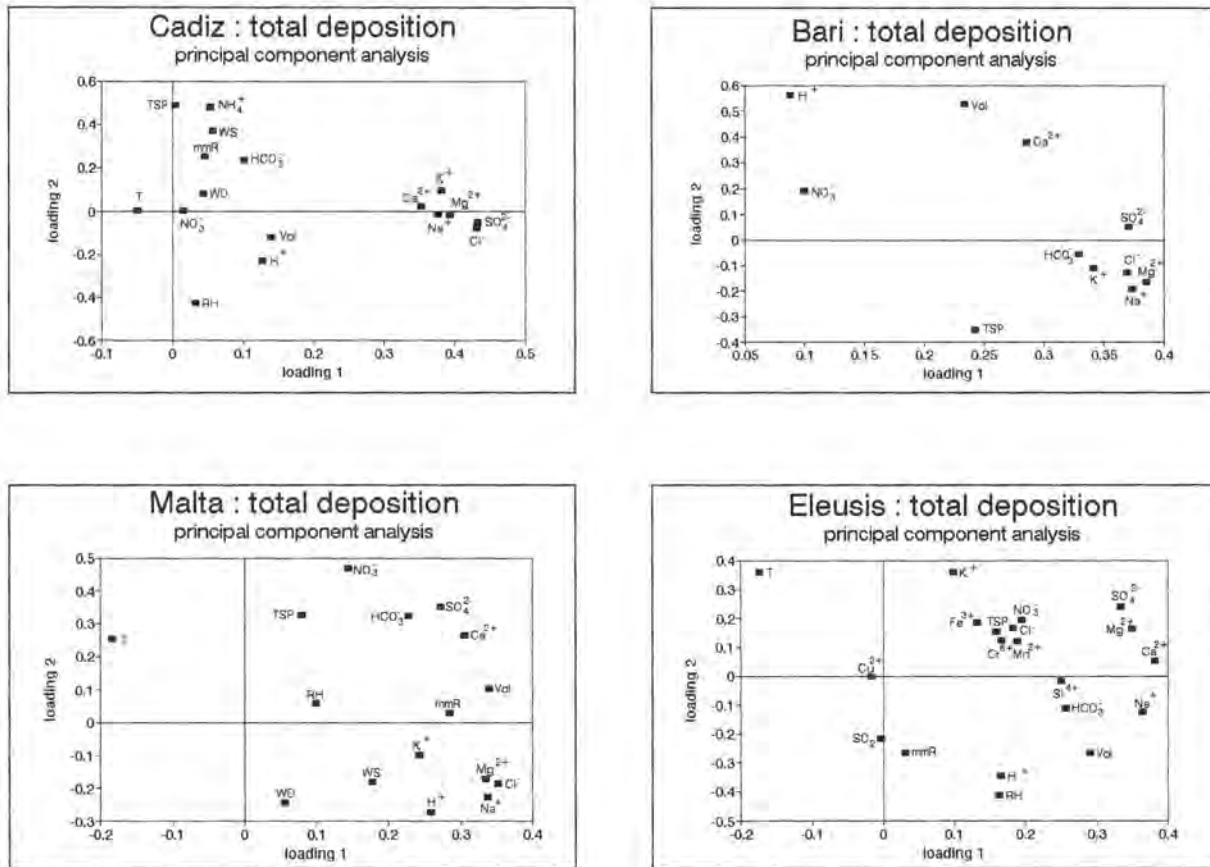
Figure 4 Loading plots of the deposition.

For the total deposition in Cadiz, the first factor is composed of Cl^- , SO_4^{2-} , Mg^{2+} , N^{ox} , K^+ and Ca^{2+} . These variables form one cluster in the loading plot and are therefore related to the same source: they reflect the combination of sea derived elements and anthropogenic

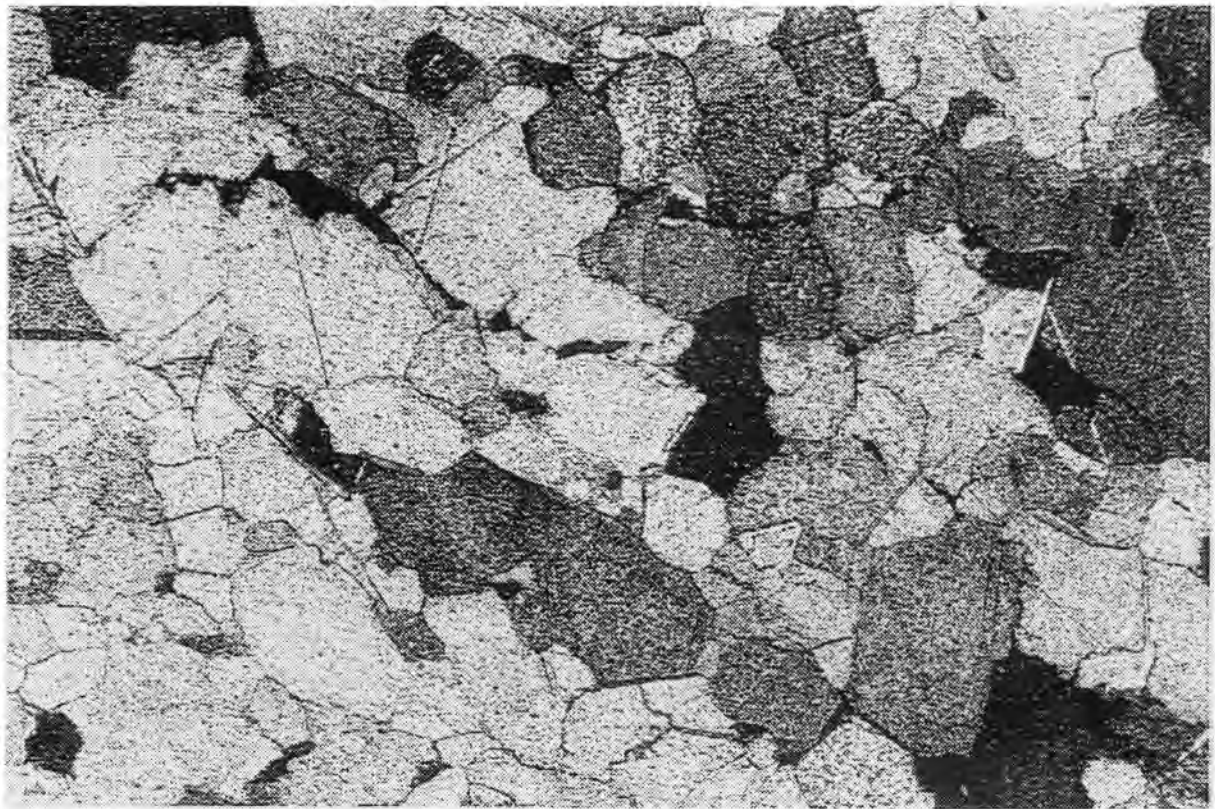
Figure 1a. Pentelic marble. Fissure between calcite grains. (Eleusis) x40. P.N.

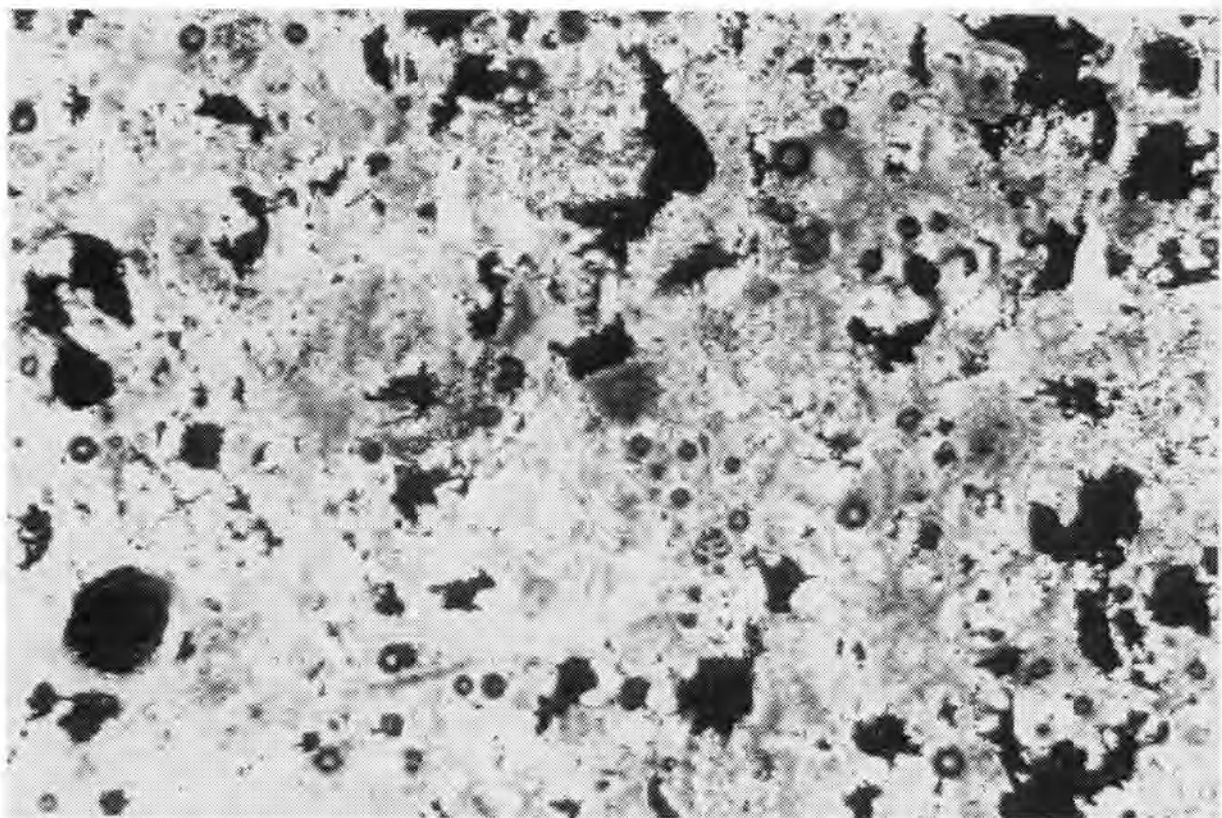
Figure 1b. Glogiberina limestone with some rounded fine grained aggregates of glauconite. (Malta). x92. C.N.

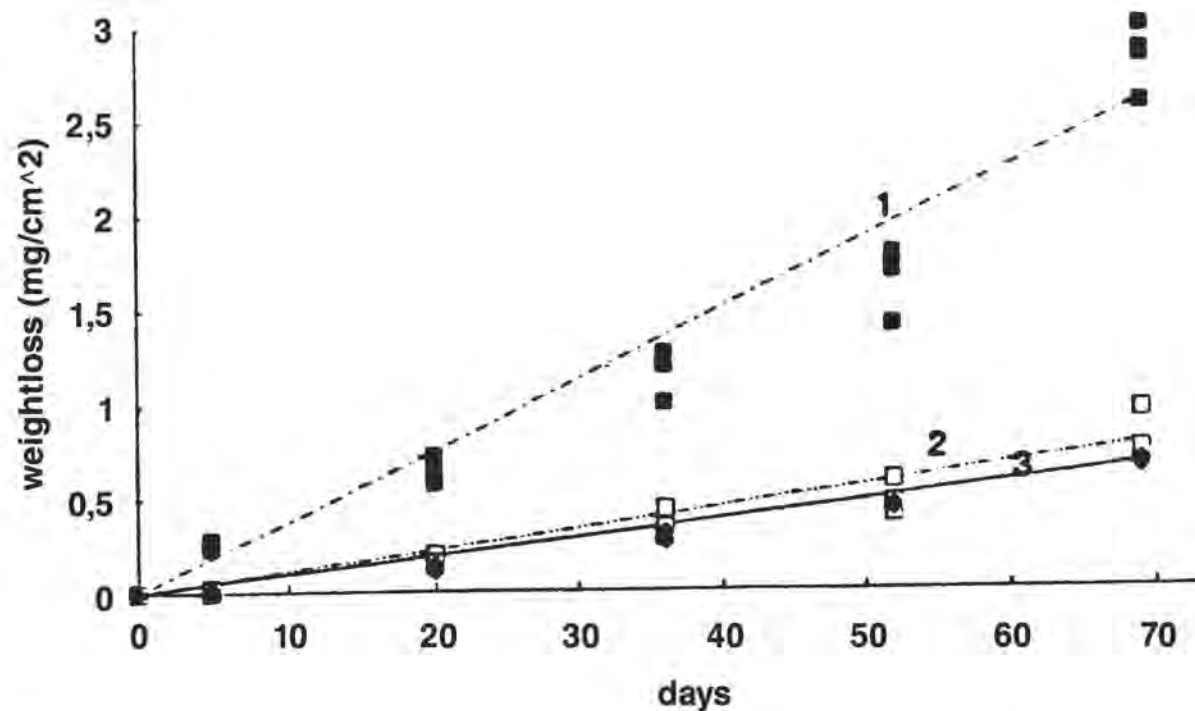
Fig. 2. Salt spray test on unprotected and protected Pentelic marble (1. unprotected, 2. protected with reversible polymer, 3. protected with pigmented reversible polymer).

The results for weight loss are shown in Figs 2–10.

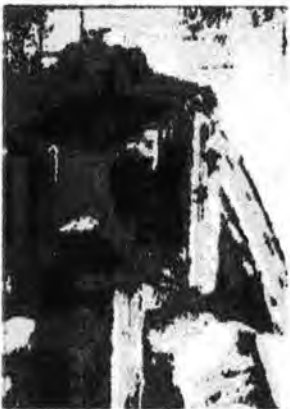
Fig. 5

BARI CATHEDRAL

Blue, Dark Brown, Black: black crust
Yellow: granular disaggregation, detachments

Purple: humidity sources

parts, the aerosols are deposited in greater quantities on the cold surfaces of stone materials which they reach first and on which they stagnate, roofs, narrowing areas (eg. the bases of domes), overhanging capitals and cornices thereby become the sites of greatest condensation. The Cathedral of Bari is an emblematic case where not only the humidity levels in the internal stone facing of the dome but also the distribution of soluble salts in the same parts of the building confirm this interesting reconstruction which was verified with on site tests by means of microbores for the sampling of powders for analyses (fig. 5).

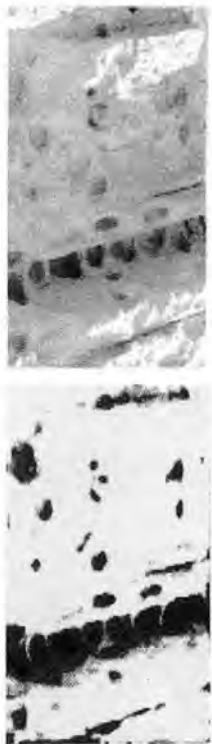
STA. MARIAIA TA' CWERRA IN MALTA Black, Brown, Blue: buried forms (holes) in correspondence of "bioturbations". Green to Yellow: less weathered rock

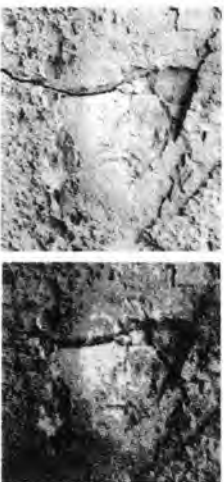
SANCTUARY OF DEMETER IN NELEUSIS Black, Violet: fissuring Yellow: detachments Brown: chips close to detachment

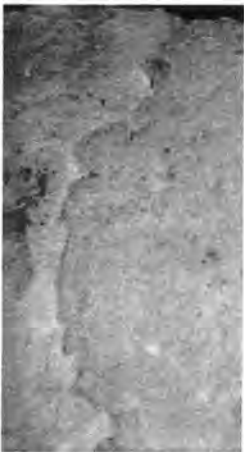
CADIZ CATHEDRAL

Blue: fissuring

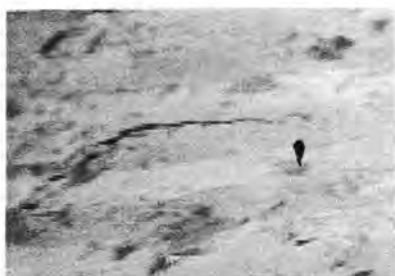
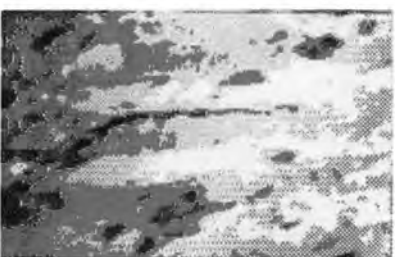
STA. MARIJA TA' CWERRA
IN MALTA

Black: Blue: fissuring

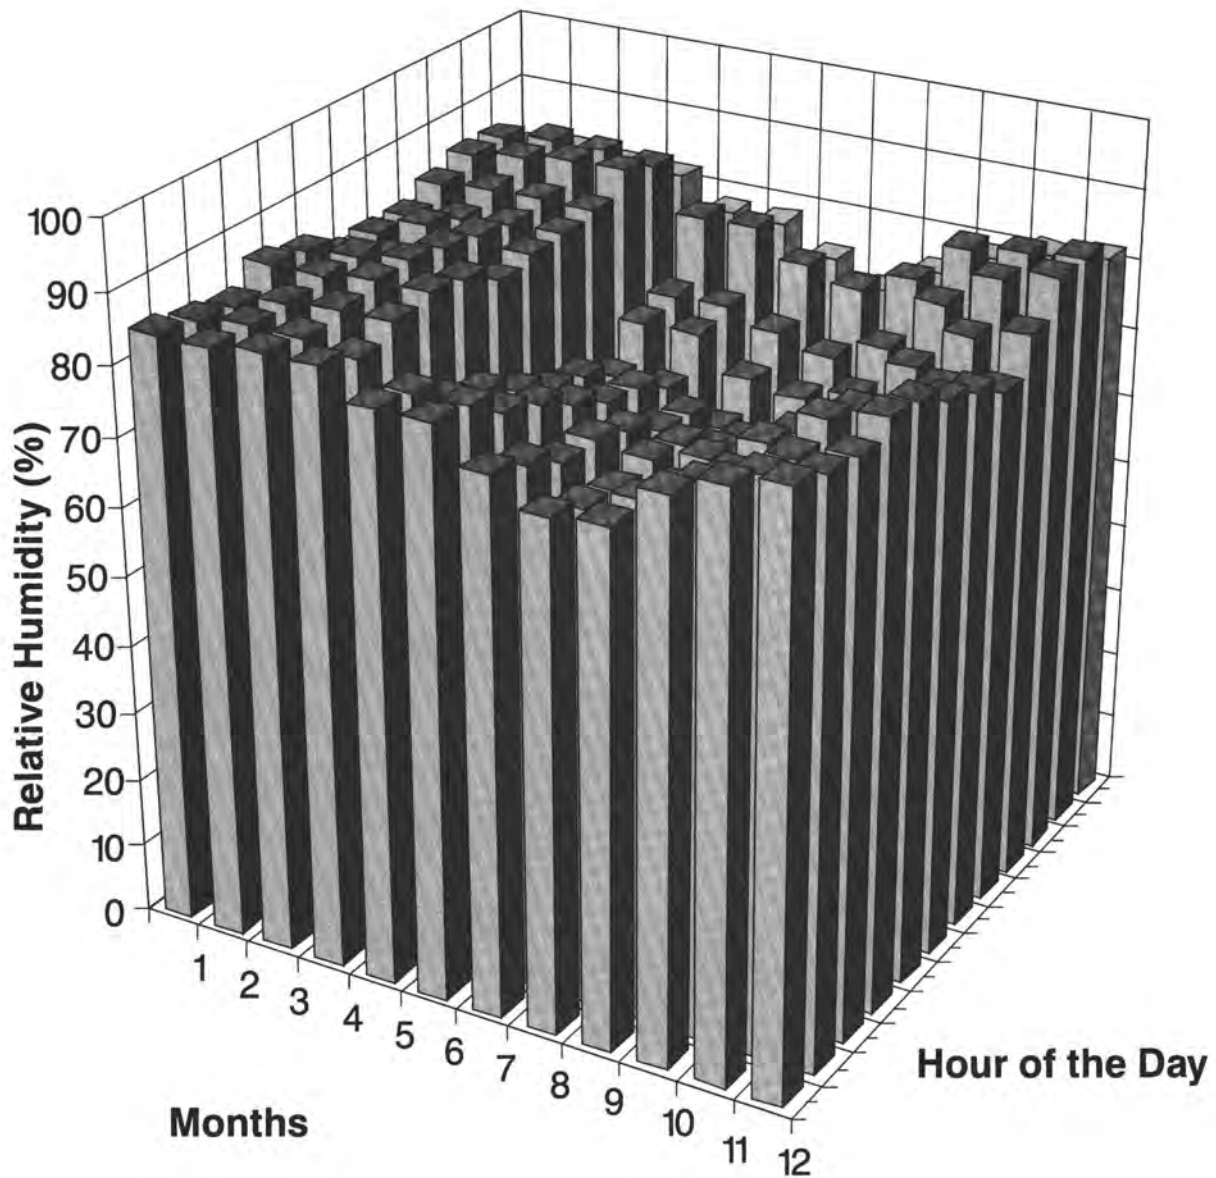
Fig. 1 Daily and seasonal values of relative humidity (RH) and air temperature (T) at Venice

stone conservation, due to adverse natural conditions determined by climatic cycles and sea spray contamination, worsened by the presence of anthropogenic pollution. Venice is one of them and will be presented here to elucidate the problem with reference to the daily and seasonal values of relative humidity and air temperature (Fig.1).

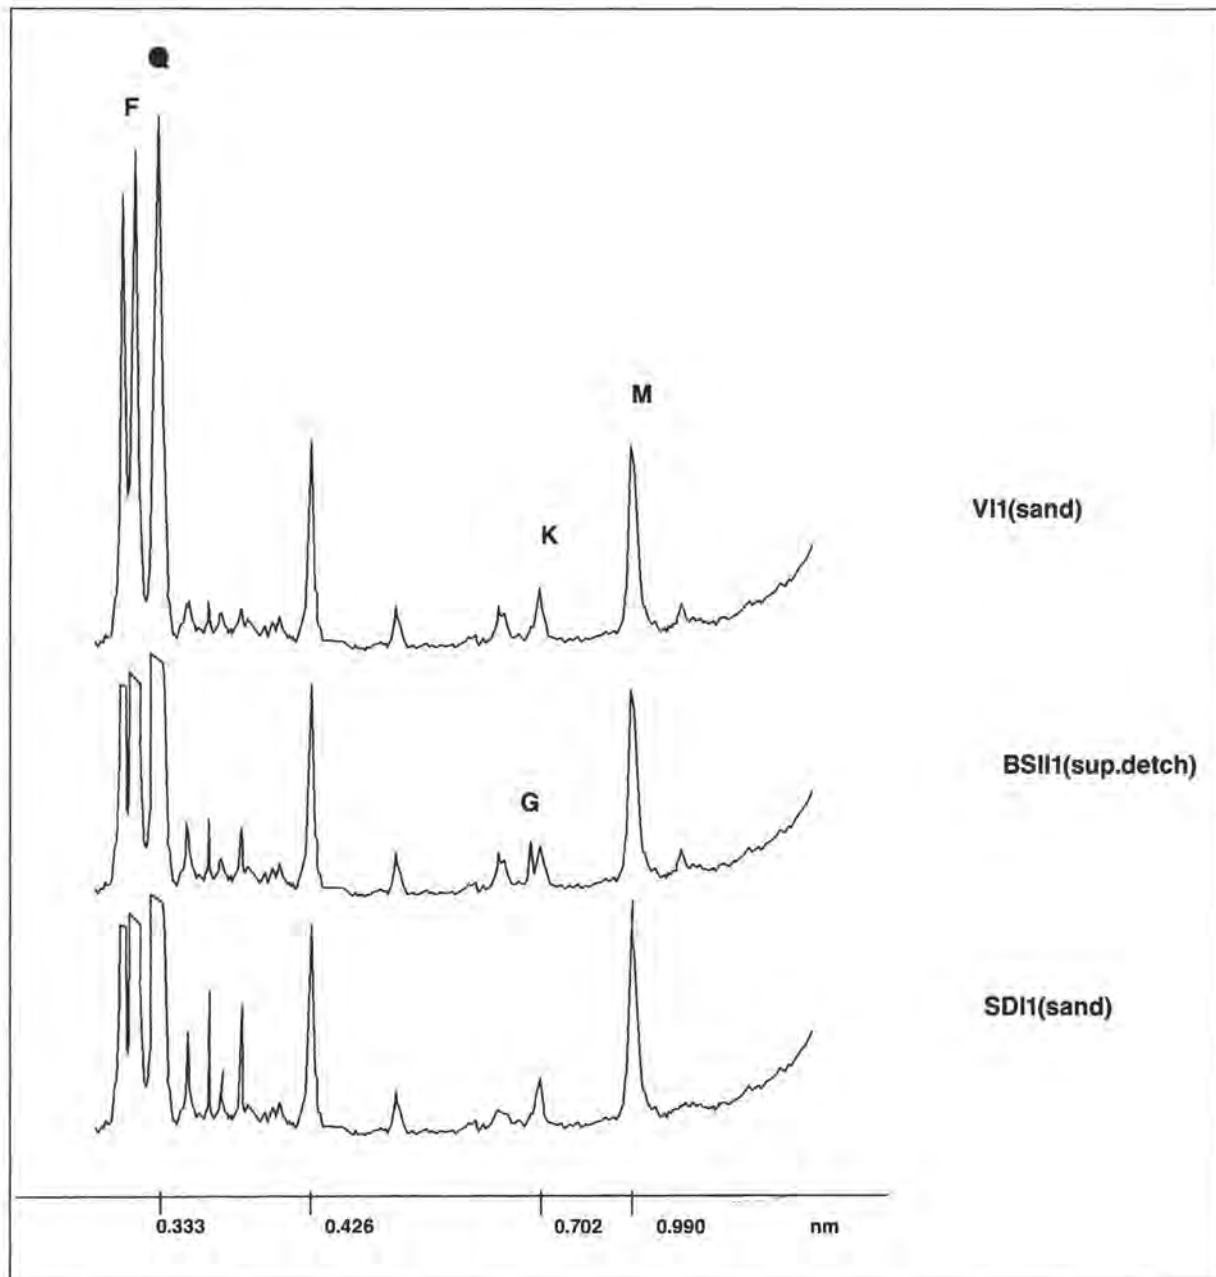
Figure 2 X-ray diffraction of some samples from the churches. M: Mica; Q: Quartz; F: Feldspars; G: Gypsum; K: Kaolinite.

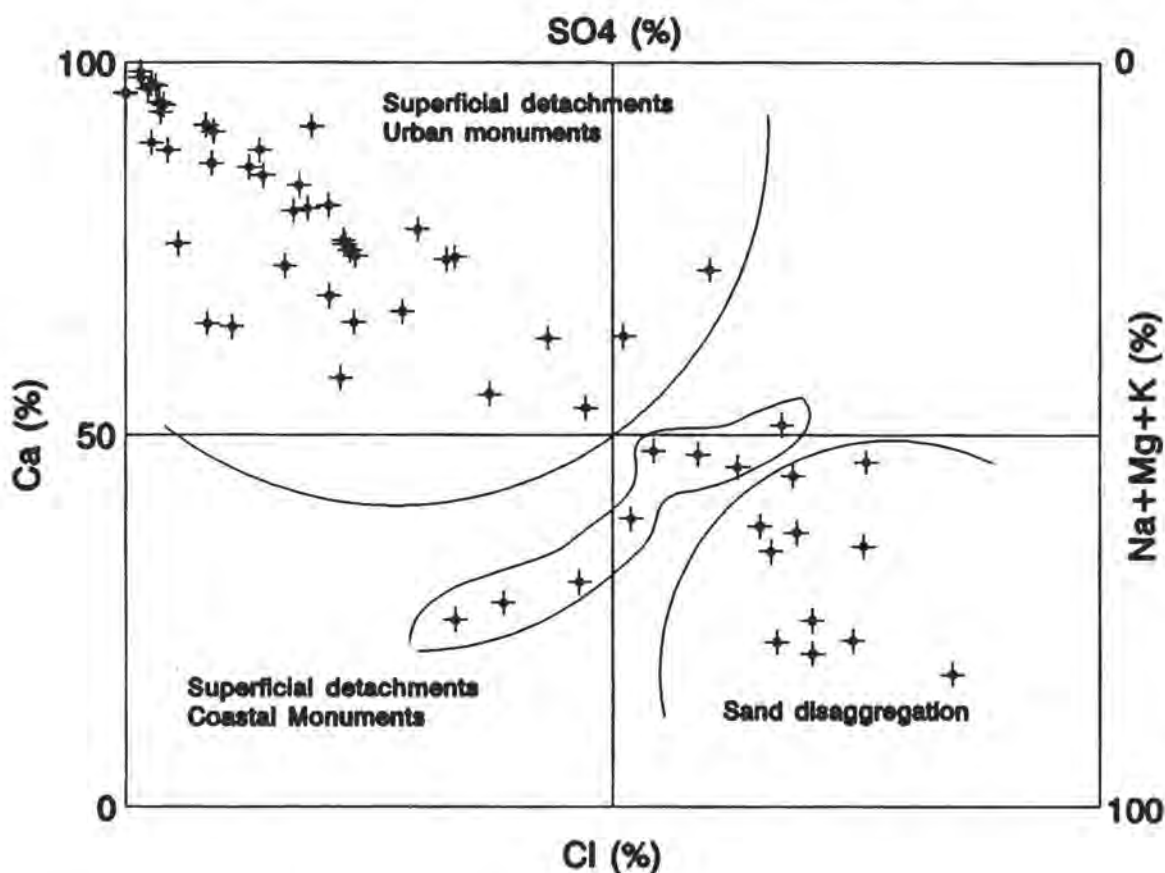
Figure 8 Langelier-Ludwing of ion content of superficial detachments and sand disaggregation of coastal and urban monuments.

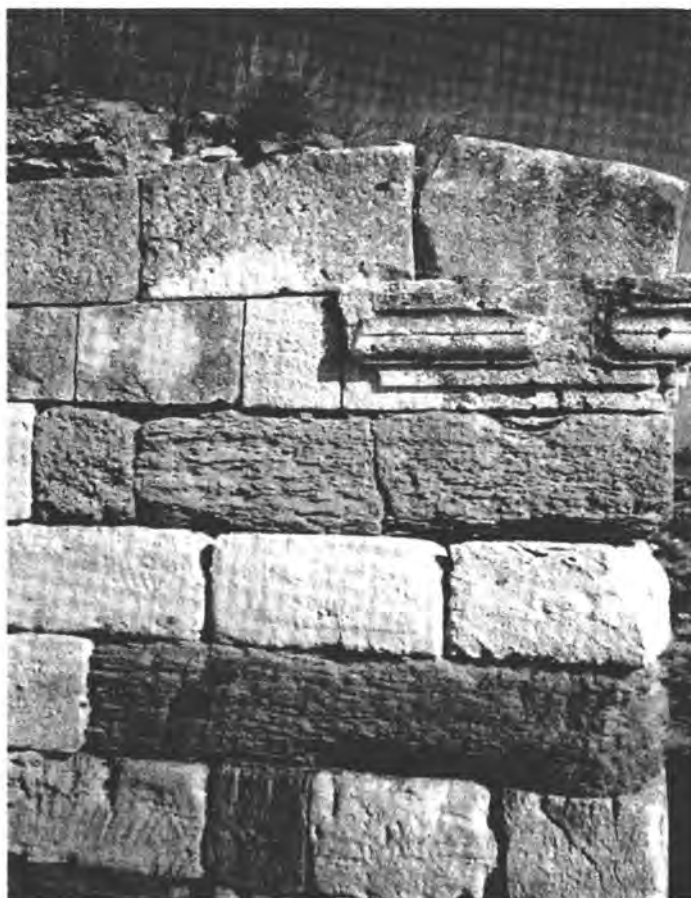
Fig.1 The left wall of the Small Gate. Map of the weathering forms

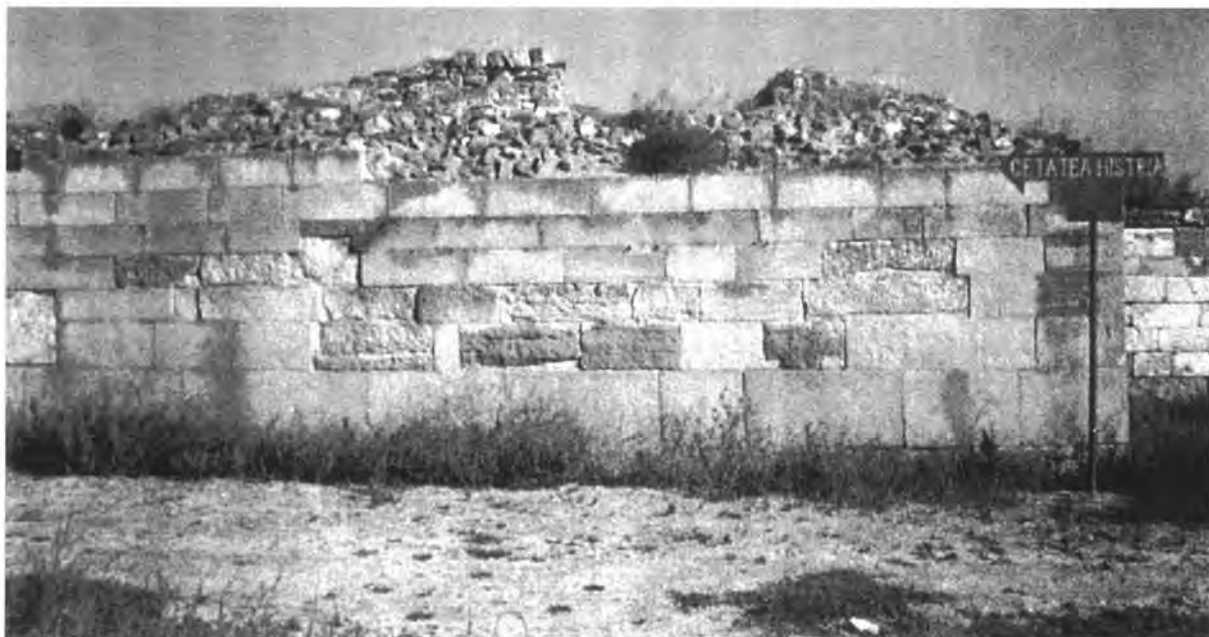
Fig.4 The east side of the I tower. Map of the weathering forms

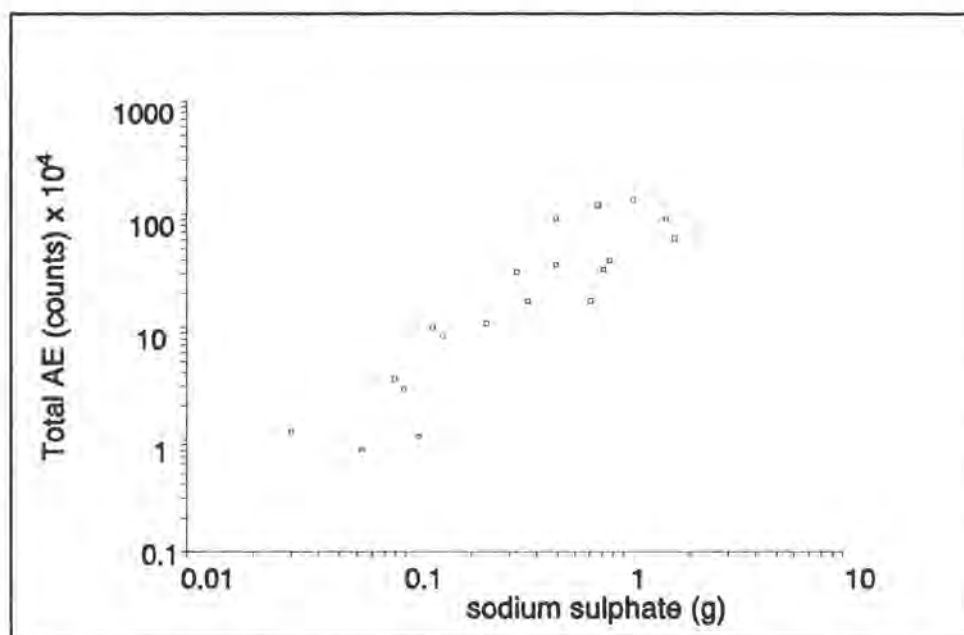
Fig. 4 Acoustic emission monitored during cooling versus amount of sodium sulphate precipitated during drying.

When a substantial amount of supersaturated solution was found at the beginning of the cooling stage, sodium sulphate decahydrate crystallised and only a minor AE was recorded (13).

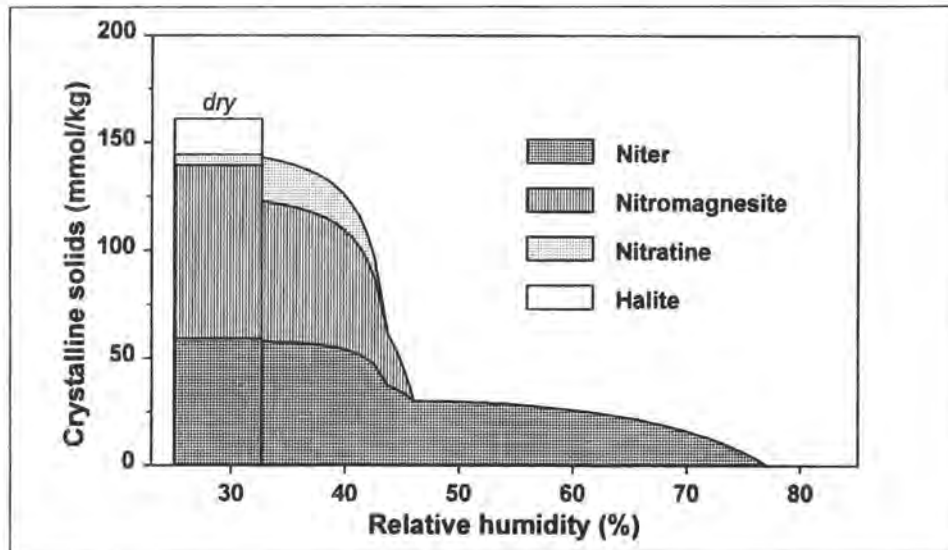
Fig. 2 Crystallization sequences at 25°C (height: 3m, depth: 0 – 0.3 cm)

It can be seen that niter (KNO₃) is the first solid to be precipitated from the salt mixture. The crystallization starts if the rela-

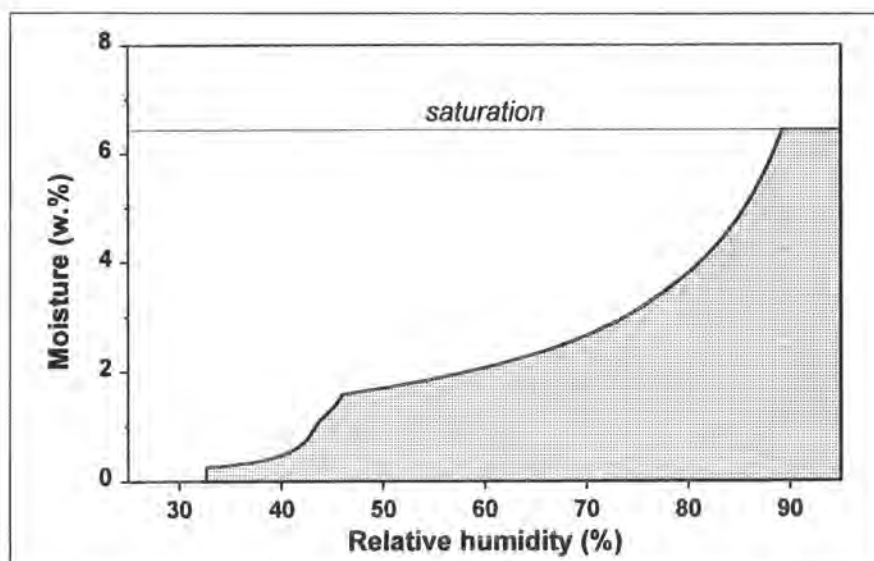
Fig. 3 Hygroscopic moisture at 25°C (height: 3 m, depth: 0–0.3 cm)

Additional calculations have been carried out to determine the influence of the salt mixtures on the moisture content of the stones. The results are shown in Fig. 3. Above 44% relative humidity the salt mixture picks up a significant amount of water. The moisture content strongly increases at humidities above 70%–75% and, finally, at a relative humidity of 89% the saturation value of the sandstone is reached (6.4 w.% of water) which means that the available pore space is completely filled with a salt solution. Due to the swelling and shrinking of the clay minerals the sandstone used at Birkenfeld Convent is very sensitive to large moisture variations. It can be seen from Fig. 3 that the hygroscopic salt mixture might therefore be also responsible for additional mechanical stress at rather high relative humidities where the salts are completely dissolved and no crystallization occurs.

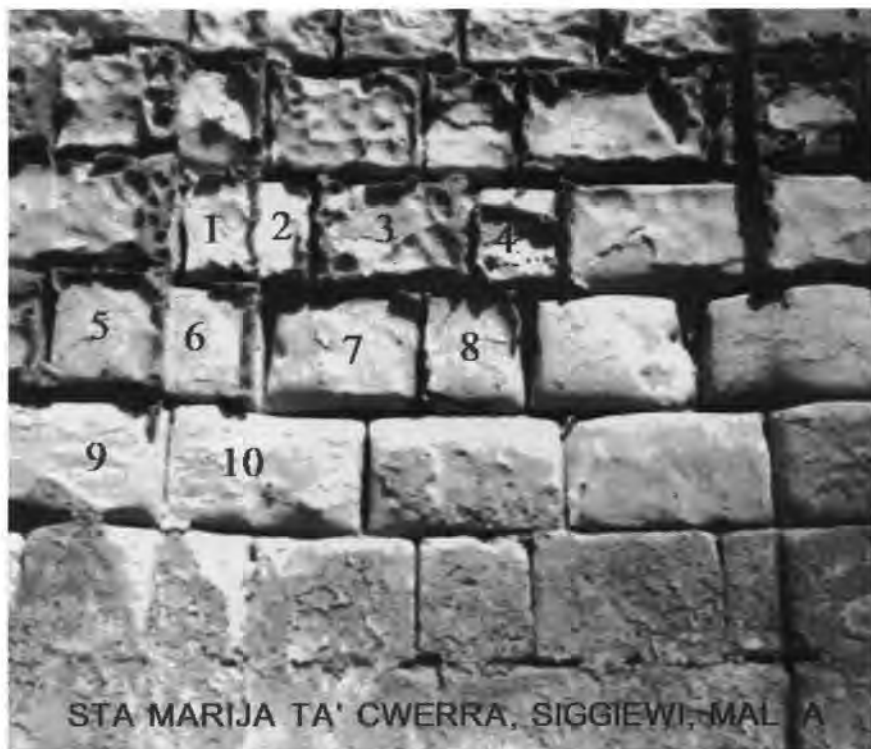
Fig. 6 A part of the external southern wall of the church. Numbers correspond the points of measurements.

Test results are given in Table 4. These results were interpreted statistically in order to determine relationships that express the interaction of the physico-mechanical properties of the stones. Tests on specimens, well prepared, taken from the south wall of the church, gave the following mean values: $d = 1.77$ gr/cc, $Ab = 15.6\%$, $V = 2.986$ Km/s, $UCS = 40.93$ Mpa, $E = 10.20$ Gpa.

According to Figure 8, the test results differ in the two layers. The uniaxial compressive strength, the elastic modulus, the ultrasonic velocity and the dry density are always higher

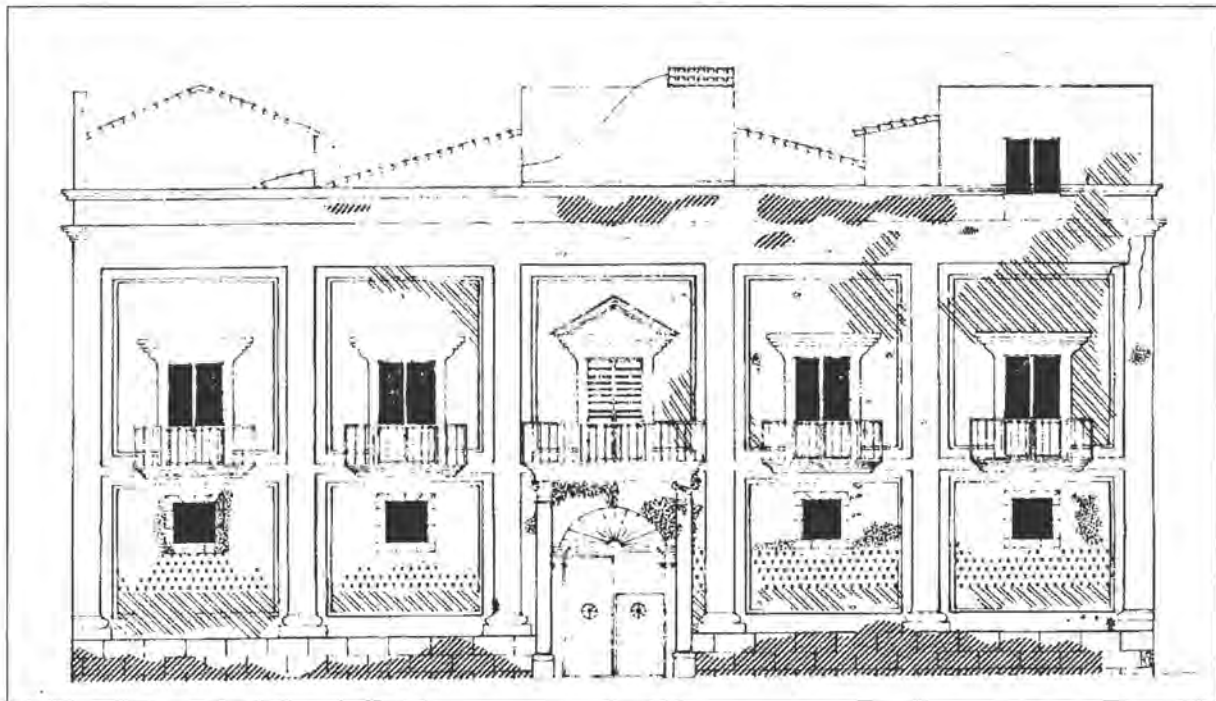
Fig. 3 Hopps façade before the last "restoration" of the left wing. The degraded areas are pointed out according to NorMaL 1/88

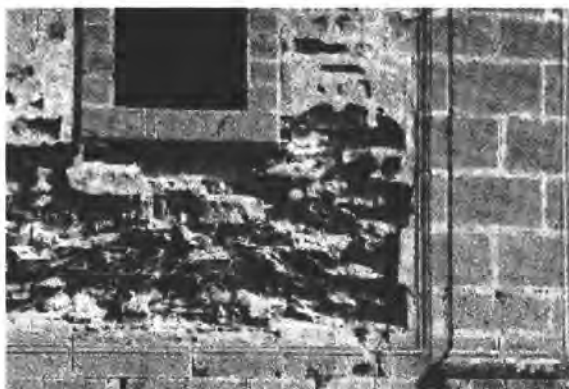
Fig. 4a Level of decay under the windows of the ground floor as compared with the good conditions of the pilaster strip

graded areas on the façade indicates the major role of water migration in the porous materials. It is caused by many different factors such as defects in the system of drain pipes and gutters, rain washing of the walls, rising of damp from the ground in to the walls, marine spray from the nearby shore. Furthermore the deep erosion of the ashlar under the windows of the ground floor could be increased also by the action of winds, carrying sand from the surroundings.

Because of the location of the palace, with its principal façade in north-west south-east direction, on the sea shore drive, exposed to strong winds of Scirocco and Maestrale and to the direct action of marine spray, as a first rough approach to diagnosis of present ruinous conditions of the building, we embraced the reasonable assumption that the most relevant contribution to stone deterioration can be related to salt decay (22).

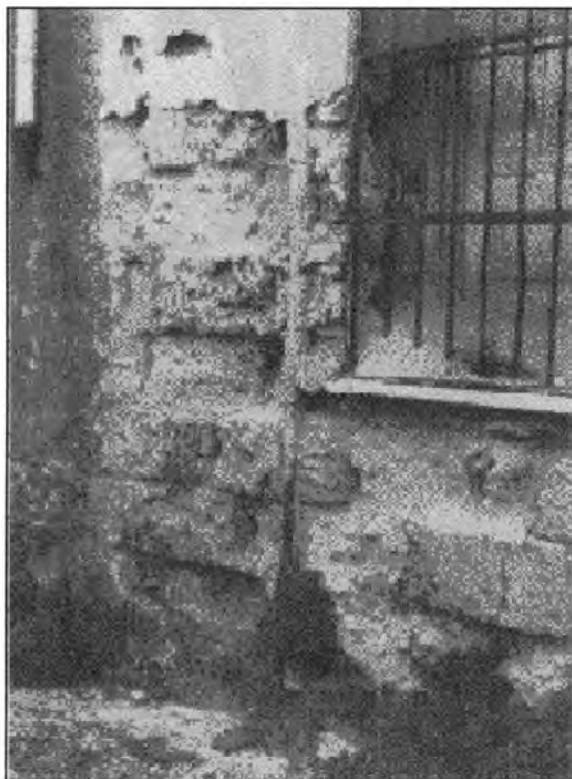
Fig. 5a Evidence of sanding process on ashlars in a building in the center of Mazara del Vallo

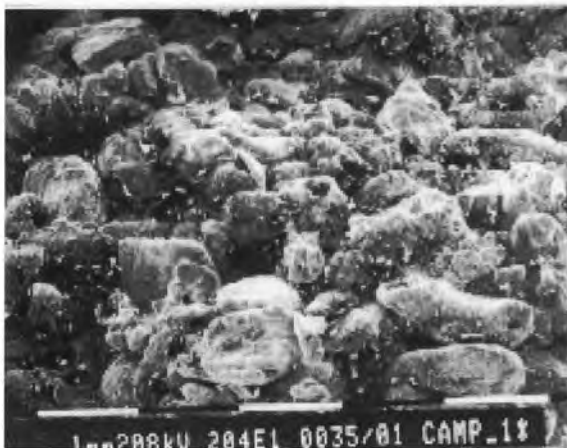
Fig. 6b Micrograph of the sample taken from degraded ashlars of the corner

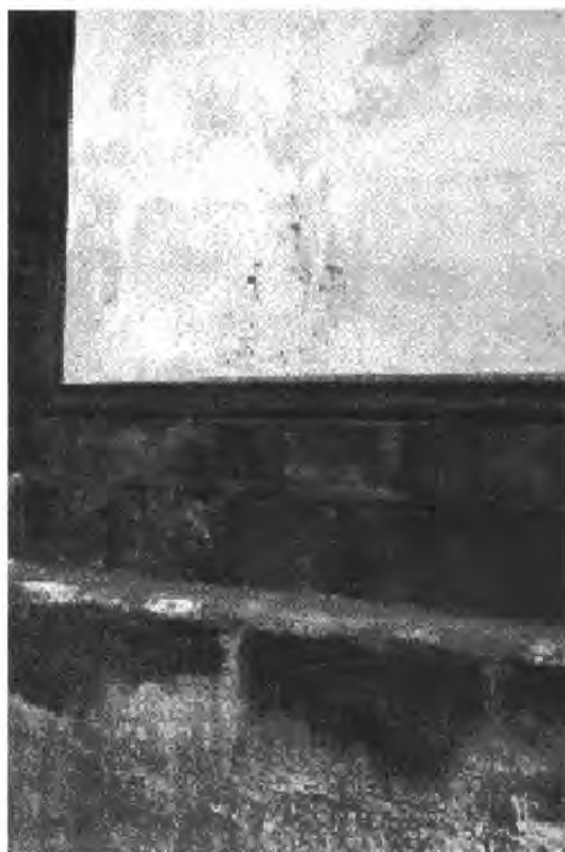
Fig. 8b Detail of the left corner of the façade with evidence of efflorescences on both the skirting board and the plaster

A thorough understanding of all degradation processes affecting the building needs further investigation. This preliminary study gives a description of the present condition of the stone and suggests the opportunity of using desalination procedure before any other improving operation. This is confirmed by the failure of a recent "restoration" intervention, not taking into account this suggestion. As shown in Figs. 8a and 8b efflorescences have already appeared on the surface of the plaster, so that a short lifetime of this protective layer can be predicted.

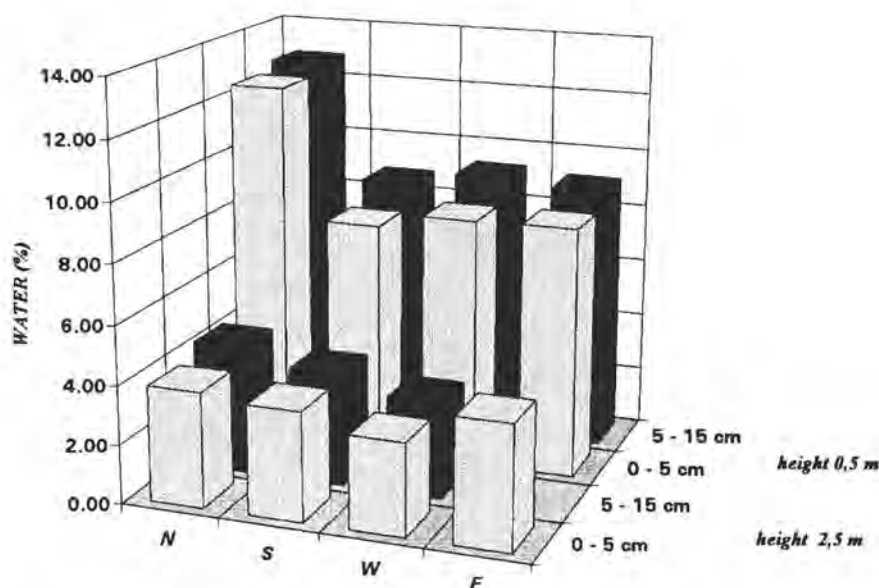
Fig. 4 Moisture content in the wall-masonry (fourth campaign).

As regards fourth campaign, only two levels: 0.5 and 2.5 m from the ground were considered (fig. 4); the highest moisture value was 12,8%, in the north wall, at 0.5 m of height and from 5 and 15 cm of depth. In both campaigns, for the other walls, the moisture reached maximum values between 8 and 9% at 50 cm of height. As regards anions, in this campaign their values were generally lower than in the third campaign. This very probably could be ascribed to different meteorological conditions, occurred before sampling campaigns. Chlorides have their maximum concentration of 1,35% at 250 cm of height and 0–5 cm of depth in the west wall, nitrates reach 0,88% at the same height and depth of the north wall, sulphates reach 0,24% at 0.5 m of height and 0–5 cm of depth in the east wall (Tab. 2).

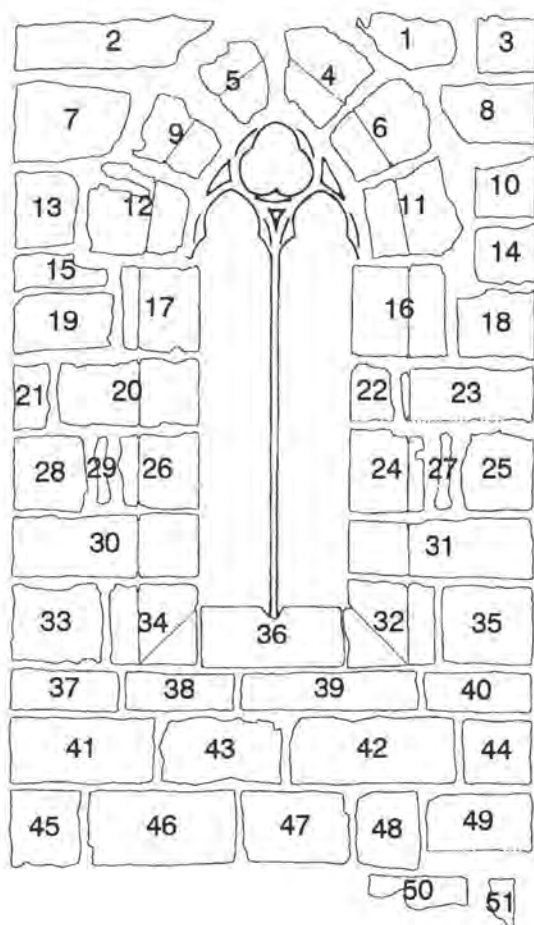
Fig. 2 Plan with numbering of building stones.

Image Analyzer – has been developed for the processing of all information gained with the monument mapping method. In a first step monument plans are digitalized and stored as raster images. The computer programme identifies all building stones, numbers them automatically and calculates their surface areas (Figure 2). Thus a basic list of reference is created. In the next step the information gained with the monument mapping are integrated for all the building stones by means of clearly defined codes (Figure 3). In this way a complete information list is set up. The information can be organized or selected systematically, can be illus-

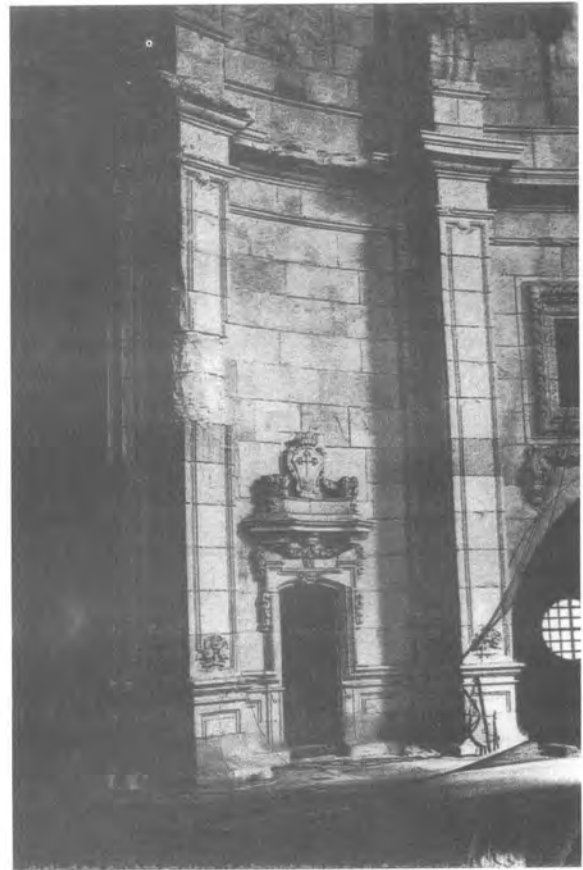
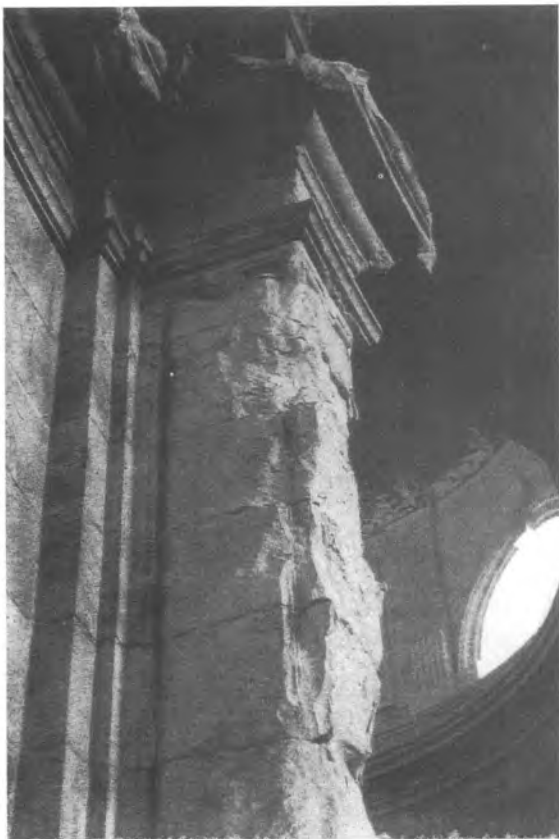
Main weathering forms: outburst, back weathering, relief, scales and scales to spalling.

Fig. 1.b. Mapping of weathered forms. Pillar inside the Cathedral.

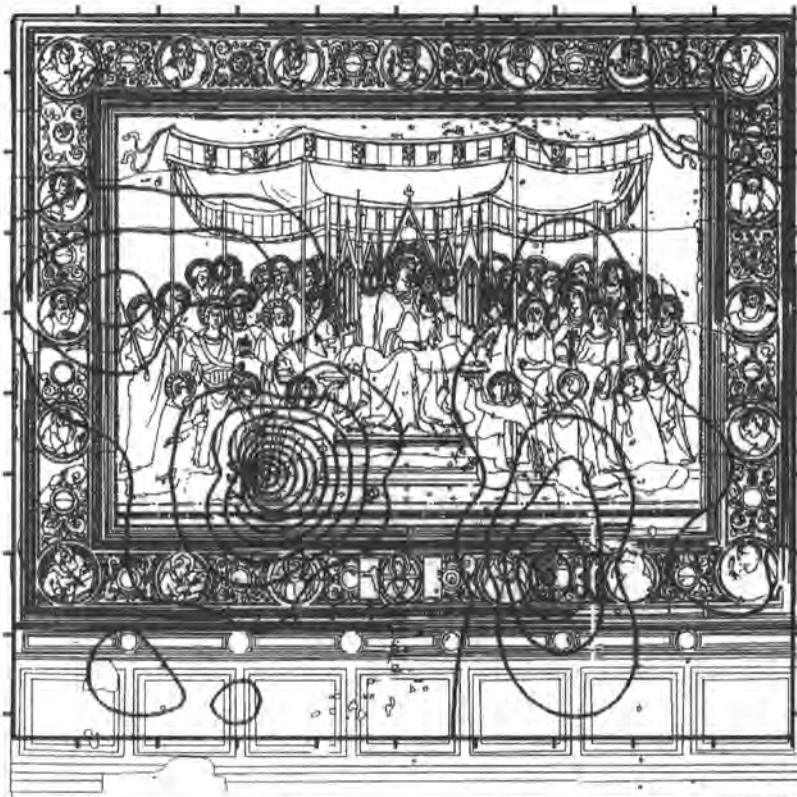
Fig. 1 Nitrates distribution on the fresco *Maestà* (Isolevel curves).

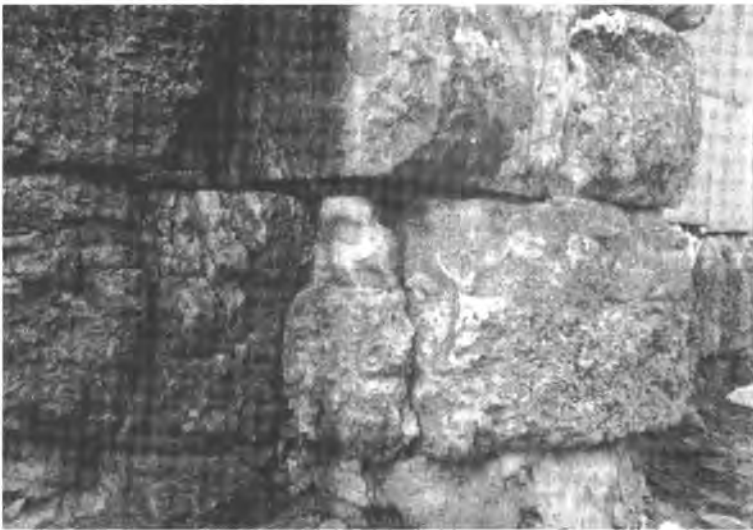
Fig. 6 Damage and deterioration of the stone

marine salts and repeated winds and frozen a long part of the year. So we found the alveolar weathering up to 100–150 mm in the interior side of the wall with orientation to Sinoe Lake and Black Sea. The same aggressive degradation we can observe on the interior side of the wall, can be nominated in the whole complex (Fig.6, Fig.7).

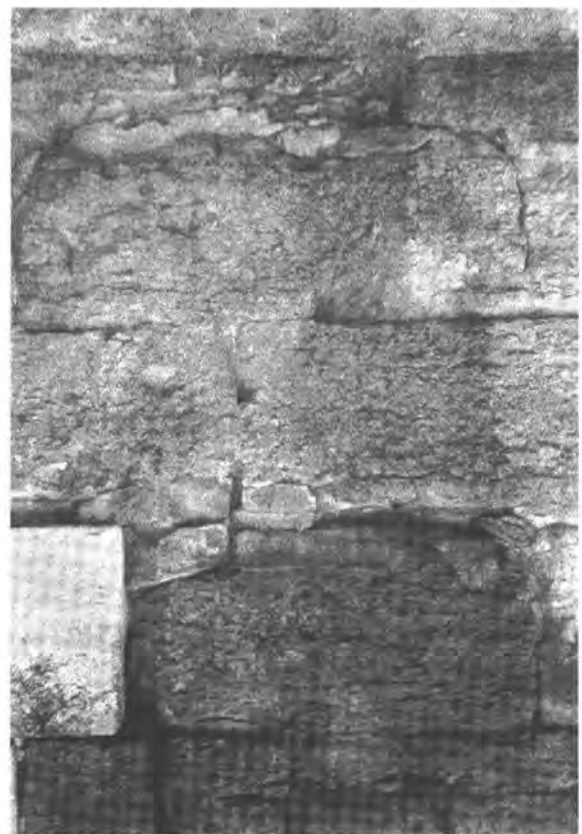
Fig. 7 Damage and deterioration of the stone

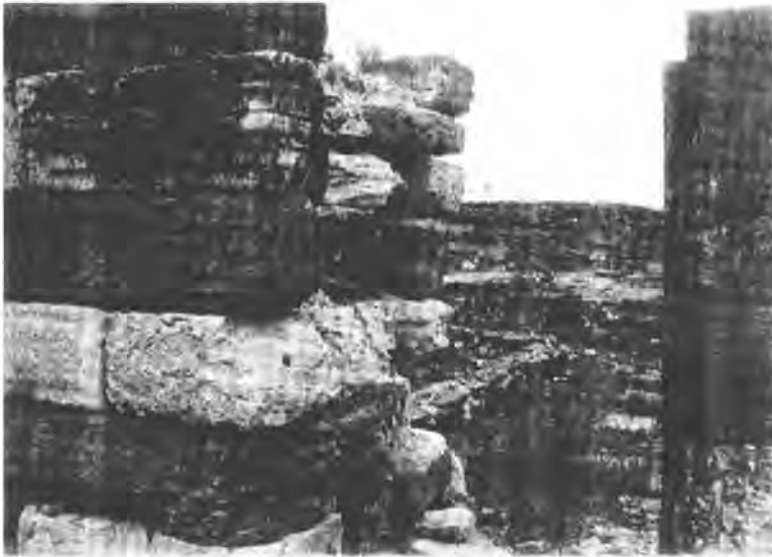
Fig. 8 Damage and deterioration of the stone

Fig.8 presents a cumulum of damages observed like: biological deposits, outbursts, granular desintegration, loss os stone material.
