ORIGIN, MECHANISMS AND EFFECTS OF SALTS ON DEGRADATION OF MONUMENTS IN MARINE AND CONTINENTAL ENVIRONMENTS

March 25-27, 1996
Bari (Italy)

Protection and Conservation
of the European Cultural Heritage
Research Report n° 4

The E.C. Project
"Marine spray and polluted atmosphere
as factors of damage to monuments in the
Mediterranean coastal environment":
objectives and results

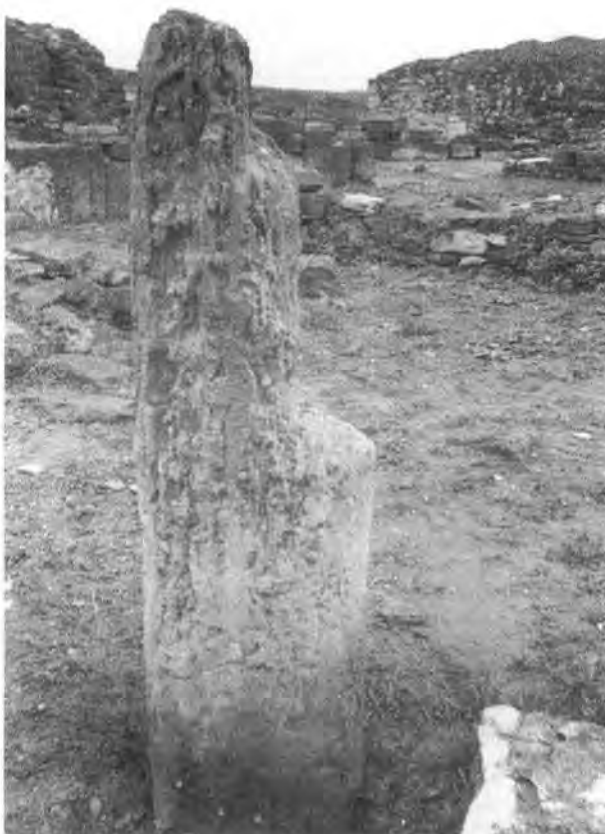
Fig. 9 Damage and deterioration of the stone

Even if the purpose of our study was the Great Roman Wall from chemical and biochemical point of view, we used as a unit for general degradation a column found in the middle of the interior territory (Fig.9). This one was all time (hundreds of years) under the atmospheric components action and suffered such important damages on its stone structure, so any sample prelevation can due to its final existence.

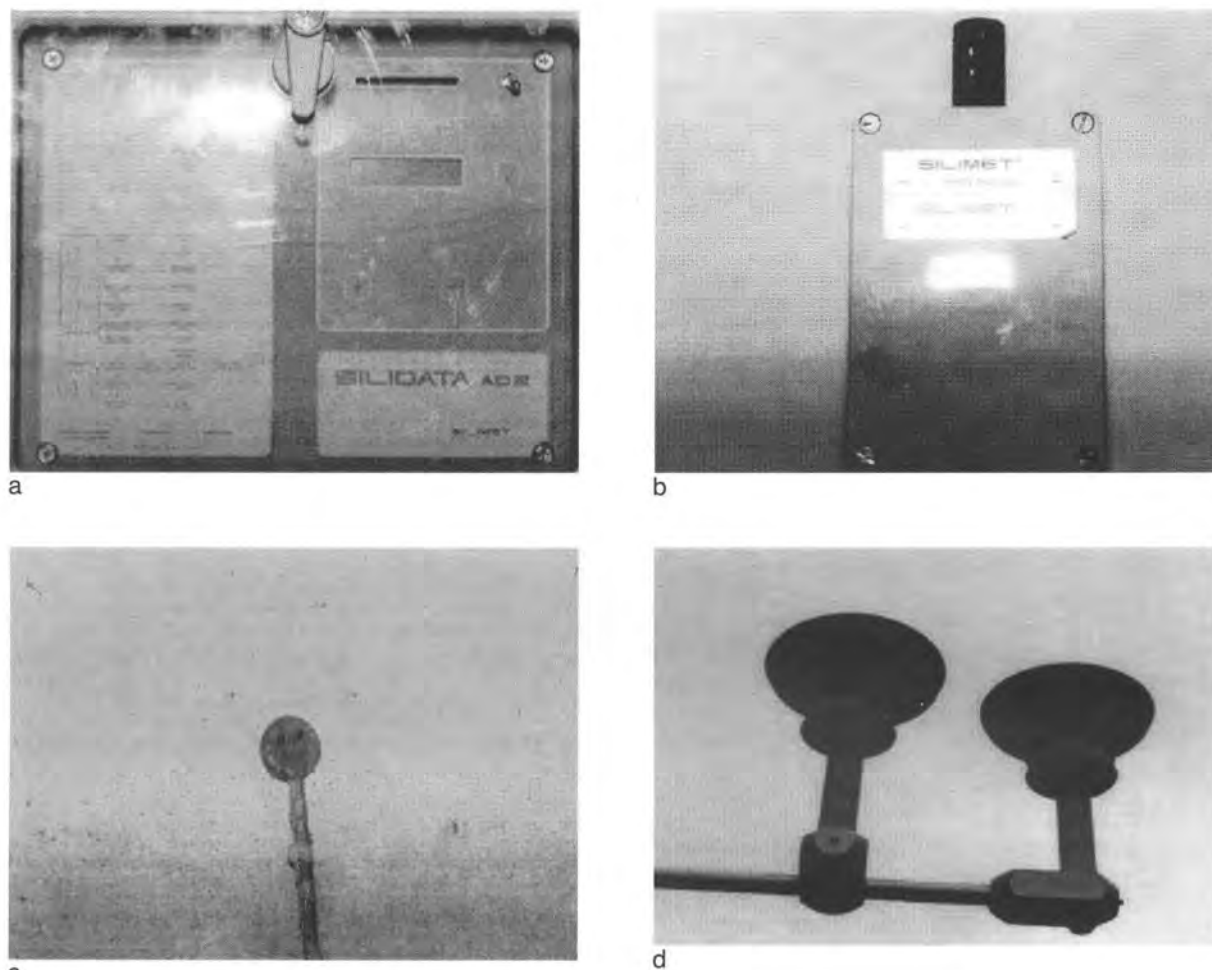
Fig. 1 Microenvironmental Monitoring Station.

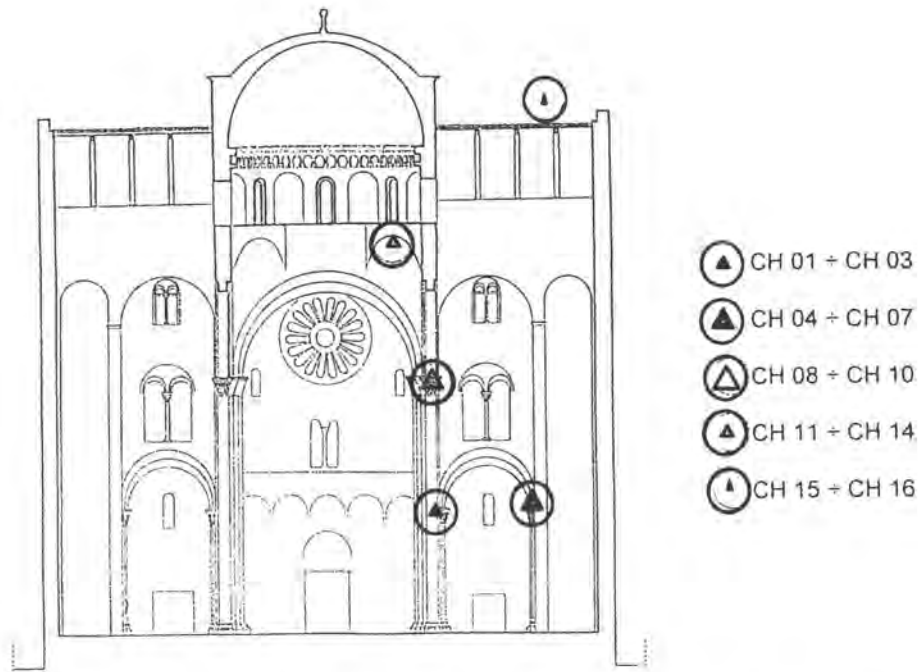
Fig. 2 Positioning of the thermo-hygrometric sensors along the vertical section of Bari Cathedral (see Table 1)
